**ROCKY LAKE DAMS
ME - 00399**

**PHASE I INSPECTION REPORT
NATIONAL DAM INSPECTION PROGRAM**

MARCH 1979

ME-00399

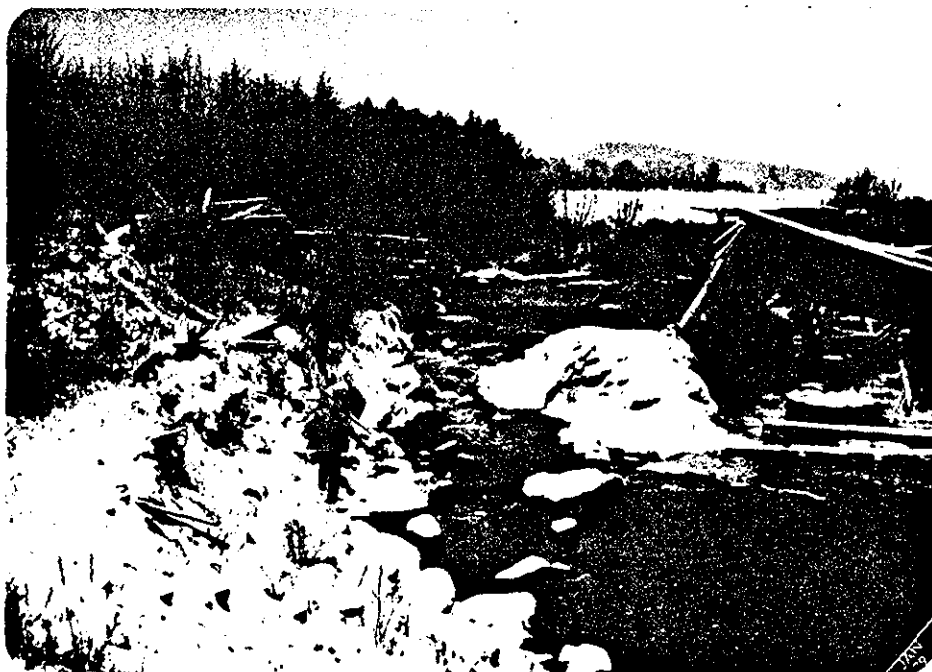
1

The Rocky Lake Dams consists of two structures about 400 feet apart and separated by an island. The spillway section of the southerly dam has been breached. The breached width is approximately 20 feet and the stream is flowing in its natural streambed through this opening. The northerly dam was found to be retaining approximately 10 feet of water.

SOUTH DAM - DOWNSTREAM FACE

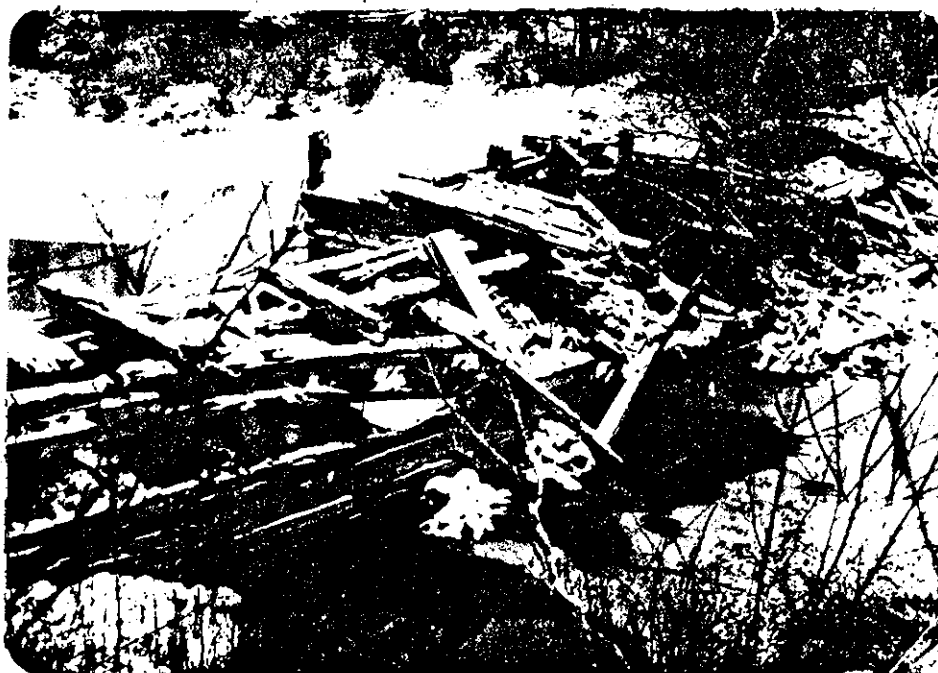
2

Both dams are constructed of stone-filled self-loading timber cribs. The timber members are seriously deteriorated and rotted. The broken timber members have become displaced and stone fill has fallen through. The penstock area and powerhouse at the southerly dam have collapsed and could not be inspected due to the hazardous condition of the dilapidated structure. The northerly dam, although seriously deteriorated is generally intact.

NORTH DAM - DOWNSTREAM FACE

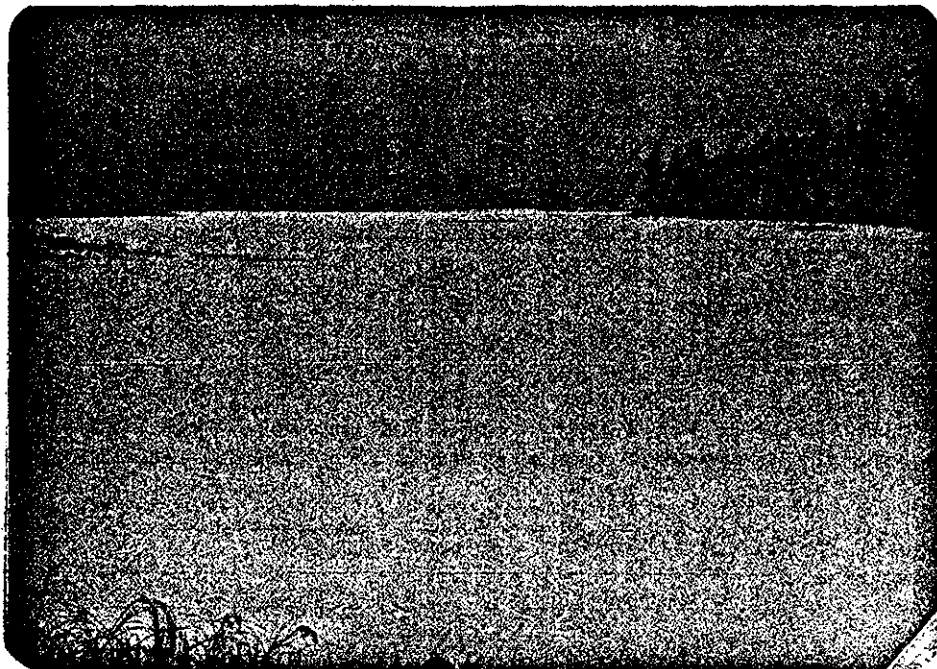
3

- d. Reservoir Area. The reservoir consists of Rocky Lake which is about 1150 acres and has a forested shoreline as shown in Photograph 3. There are a few cottages on the shore of the lake. The potential for slope failure above the dam appears minimal.
- e. Downstream Channel. The channels below the northerly and southerly dams are narrow with a slope of about 0.7 percent. See Photographs 5 and 7. Both streambeds are composed primarily of gravel and cobbles. Located about 100 feet downstream of the southerly dam is an 8.8-foot wide by 11.8-foot high culvert beneath a road. This culvert appears to restrict the channel and is likely the hydraulic control during flood flow. The north channel is littered with debris, including two fallen trees. The two channels join as they enter Orange Lake about 1500 feet downstream of the dams.

UPSTREAM CHANNEL

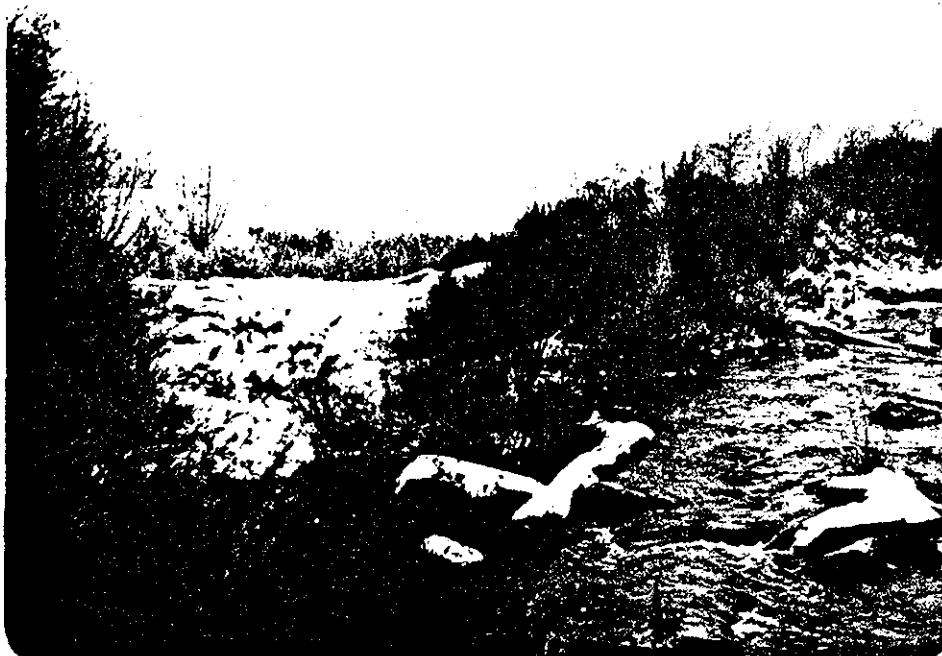
4

- b. Slope Stability. The slopes of the embankment appear generally true to line and grade and no slope stability problem appears to exist.
- c. Seepage. Very minor seepage was occurring at the downstream toe of this structure.
- d. Drainage Systems. None were observed.
- e. Slope Protection. Logs were lying on the upstream slope of the northerly dam, a little above the water line. No other form of slope protection was in evidence. Little or no erosion was apparent on the upstream slope.

SOUTH DAM - EARTH DIKE UPSTREAM

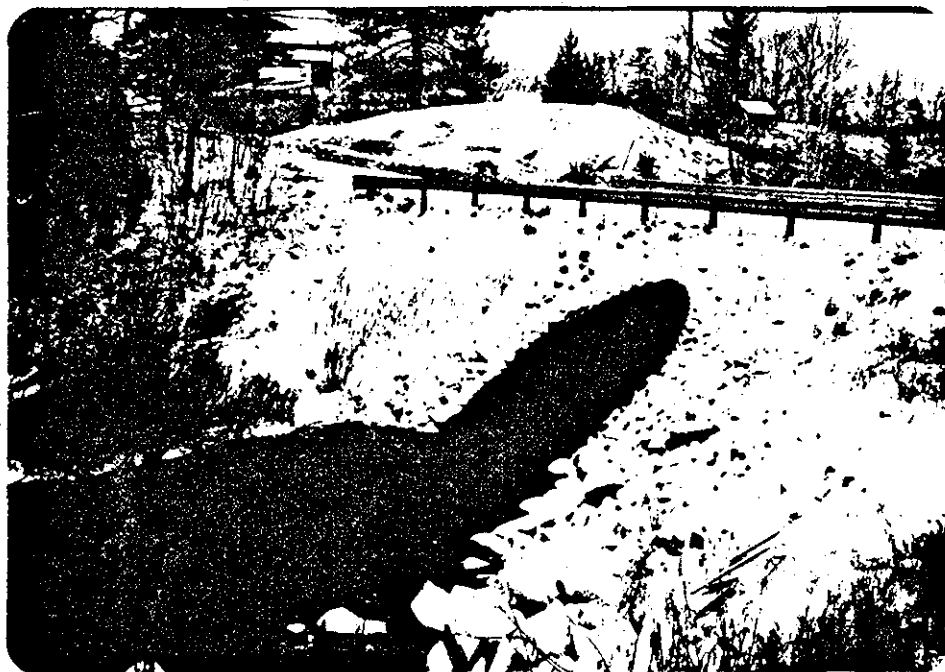
5

c. Approach and Outlet Channels. Southerly dam approach appears to be clear and unobstructed both at the embankment dike upstream and at the breached dam. The southerly dam outlet channel is generally unobstructed, however, a 8.8 foot wide by 11.8 foot high culvert exists approximately 100 feet downstream from the dam. Debris from the old dam could plug this culvert during high flow conditions. The approach channel to the northerly dam was generally clear. However, a beaver lodge exists approximately 30 feet upstream of the dam near the north bank and debris from this area could clog the spillway or outlet sections of the dam structure. The outlet channel is lined with trees and could be easily obstructed by debris from the dam or debris passing over the dam.

SOUTH DAM - DOWNSTREAM CHANNEL

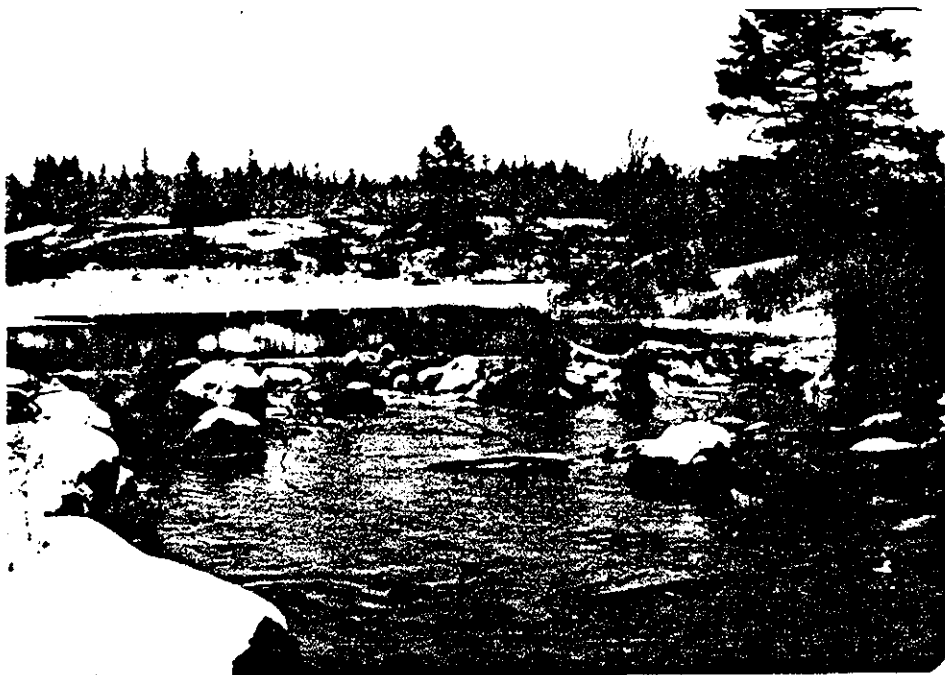
6

SOUTH DAM - UPSTREAM CONTROL
